DPX-1 SERVICE MANUAL

Service Center Memo: DPX-1 Engineering Changes + Prommer Service Bulletin

Oberheim Service News

DPX-1 Revisions

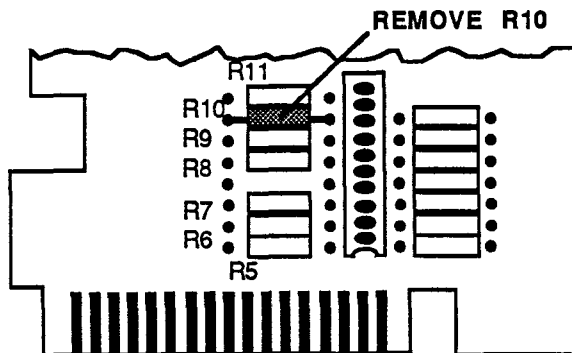
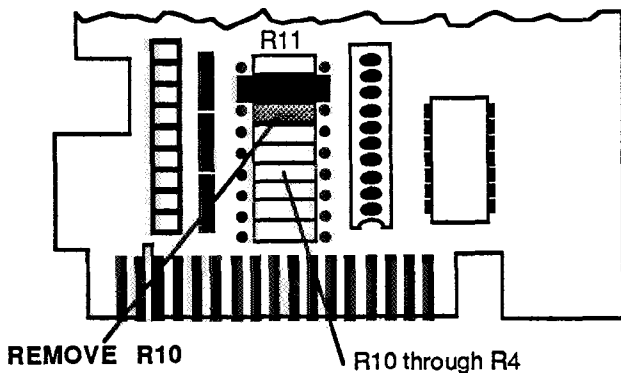
EFFECTIVITY	REASON FOR CHANGE
<input type="checkbox"/> AS REQUIRED IN TEST <input checked="" type="checkbox"/> FUTURE PRODUCTION <input checked="" type="checkbox"/> RETROFIT PRODUCTION & INVENTORY <input checked="" type="checkbox"/> RETROFIT IN FIELD <input type="checkbox"/> AS NEEDED <input type="checkbox"/> DRAWING CORRECTION ONLY <input type="checkbox"/> PARTS PURCHASING	To decrease loading on motor line of 5 1/4" Disk Drive. Affects Toshiba drive assemblies only.
	ECO 1104 - Page 1 of 1.

Remove resistor R10 (150Ω) from the 5 1/4" disk drive's PCB according to the instructions below and the accompanying diagrams.

4. Carefully de-solder resistor R10 and remove it from the board. It may then be discarded. Refer to the illustration below for proper identification of this component. The diagrams refer to two different versions of the Toshiba 5 1/4" disk drive. One of these drawings is relevant to the unit you are updating.

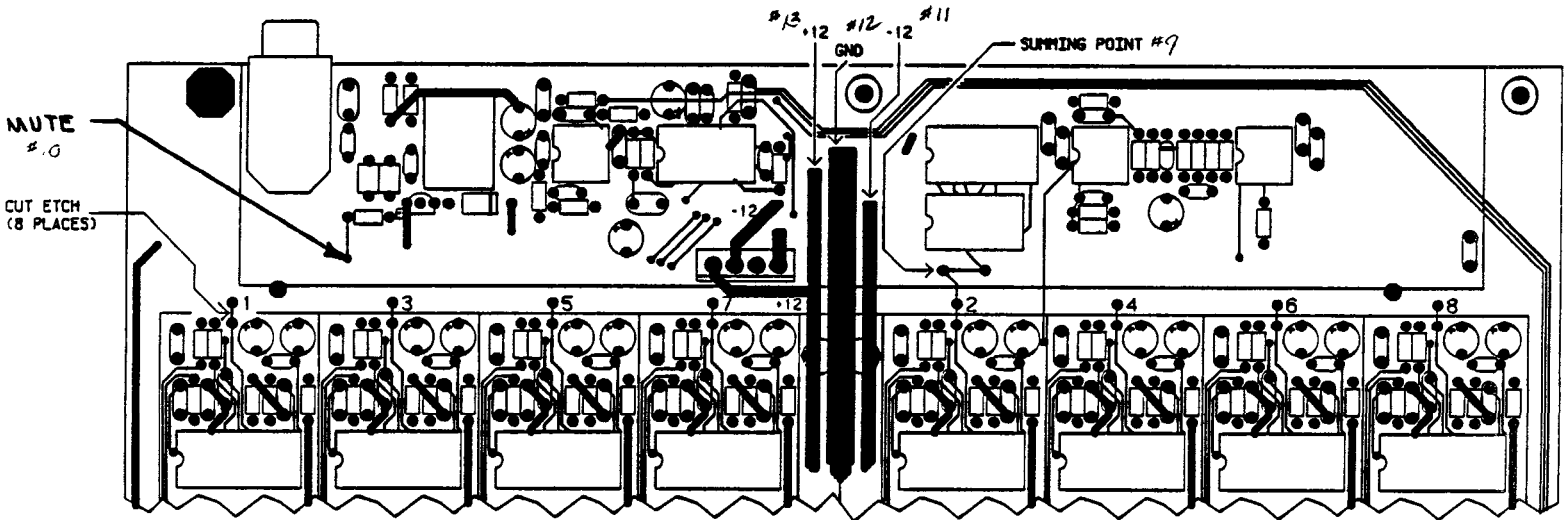
DPX-1 Voice Outputs Cable Update Kit – Part #770107.

EFFECTIVITY	REASON FOR CHANGE
<input type="checkbox"/> AS REQUIRED IN TEST <input checked="" type="checkbox"/> FUTURE PRODUCTION <input checked="" type="checkbox"/> RETROFIT PRODUCTION & INVENTORY <input checked="" type="checkbox"/> RETROFIT IN FIELD <input type="checkbox"/> AS NEEDED <input type="checkbox"/> DRAWING CORRECTION ONLY <input checked="" type="checkbox"/> PARTS PURCHASING <input type="checkbox"/> _____	Preparation of the DPX-1 analog circuitry for the optional installation of Individual Voice Outputs. ECO 1105 – Page 1 of 2. Document Part #950077

Install 13-conductor cable assembly to DPX-1's analog board according to the instructions and diagram below.

5. Referring to the accompanying diagram, carefully cut the eight (8) printed circuit traces between the two solder pads on each Voice.
6. Solder the 13 leads of the cable assembly according to the accompanying chart. Each solder point exists as a solder pad on the printed circuitry so that each point can soldered cleanly, with no need to remove any of the green masking. When soldering the first eight Voice leads, be absolutely certain that each lead is attached to the pad that is closer to the front of the unit.

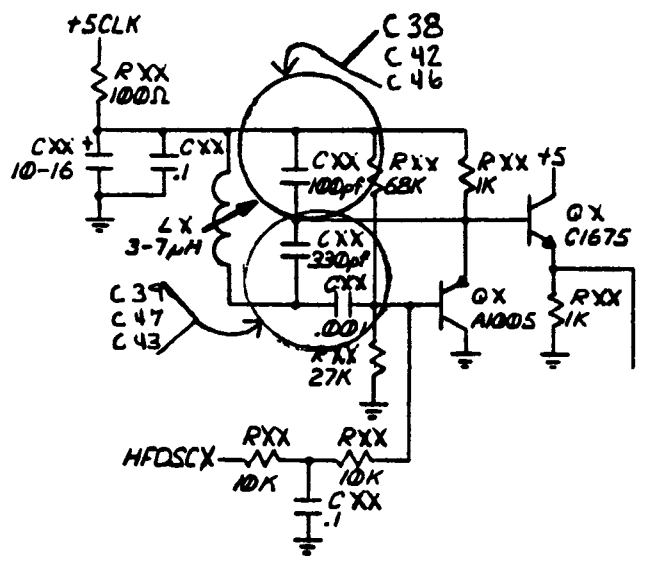
FIG. 1: One of three HFO circuits as depicted in the Matrix-6 Voice Board Schematic, Sheet 2 of 3.

1. Replace C38, C42 and C46 with 100 pF silver mica, 5% capacitors (Oberheim Part #157066).
2. Replace C39, C43 and C47 with 330 pF silver mica, 10% capacitors (Oberheim Part #157035).
3. After replacing all six capacitors, the HFOs must be recalibrated as described on Page 4 of the Matrix-6 Service Manual.
